January 2010

Real-Time River Channel- Bed Monitoring at the Chariton and Mississippi Rivers in Missouri 2007–09

IBRD Sonar Scour Monitoring Project: Real-Time River Channel-Bed Monitoring at the Chariton and Mississippi Rivers in Missouri, 2007-09

by
Paul H. Rydlund, Jr.
USGS

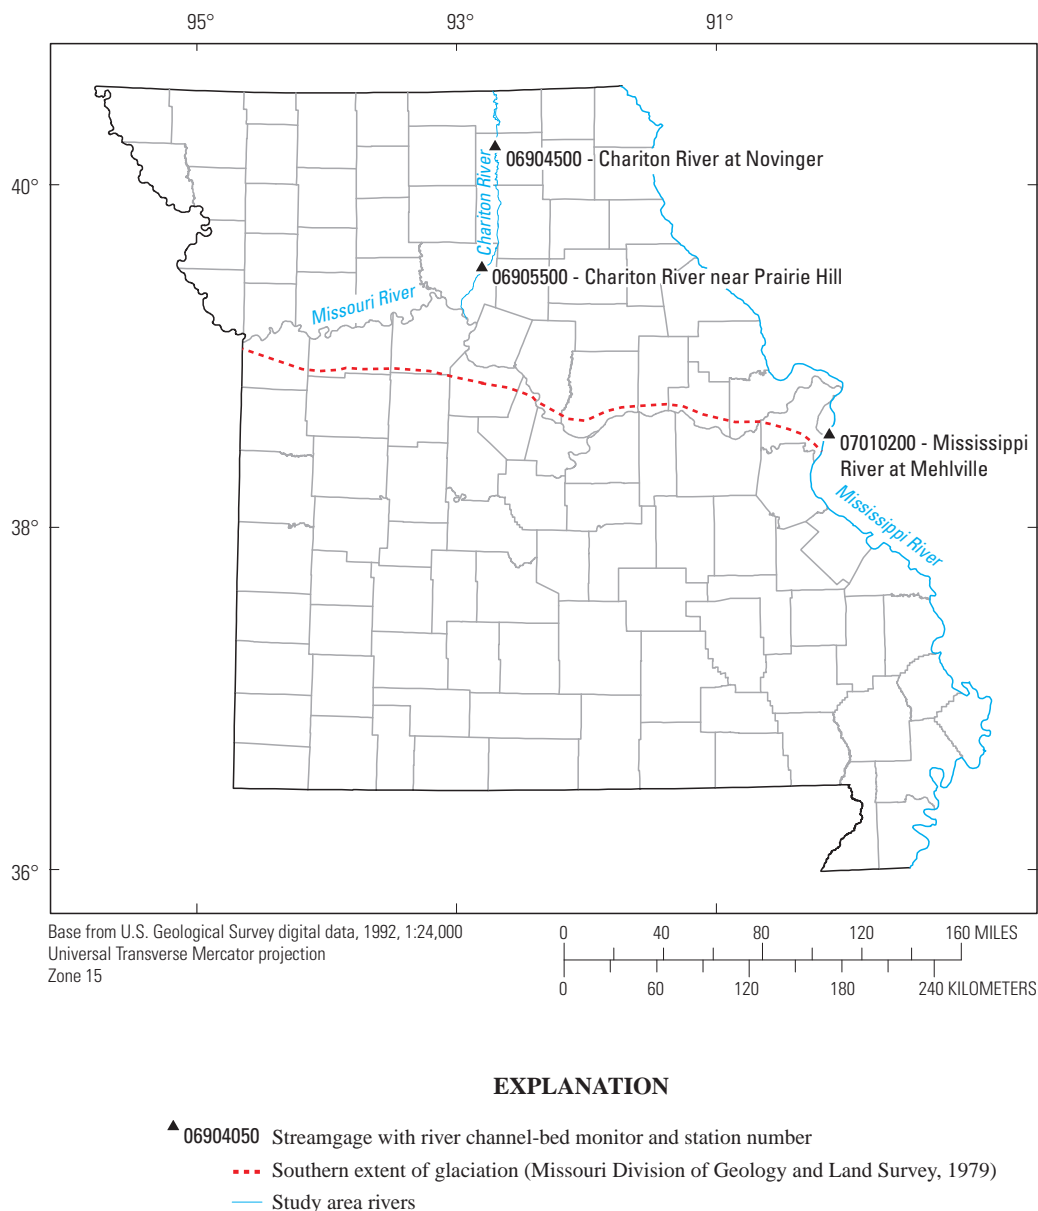
Figure 1. Location of river channel-bed monitors in Missouri.

location on the Mississippi River (fig. 1) between August 20, 2007, and August 24, 2009.

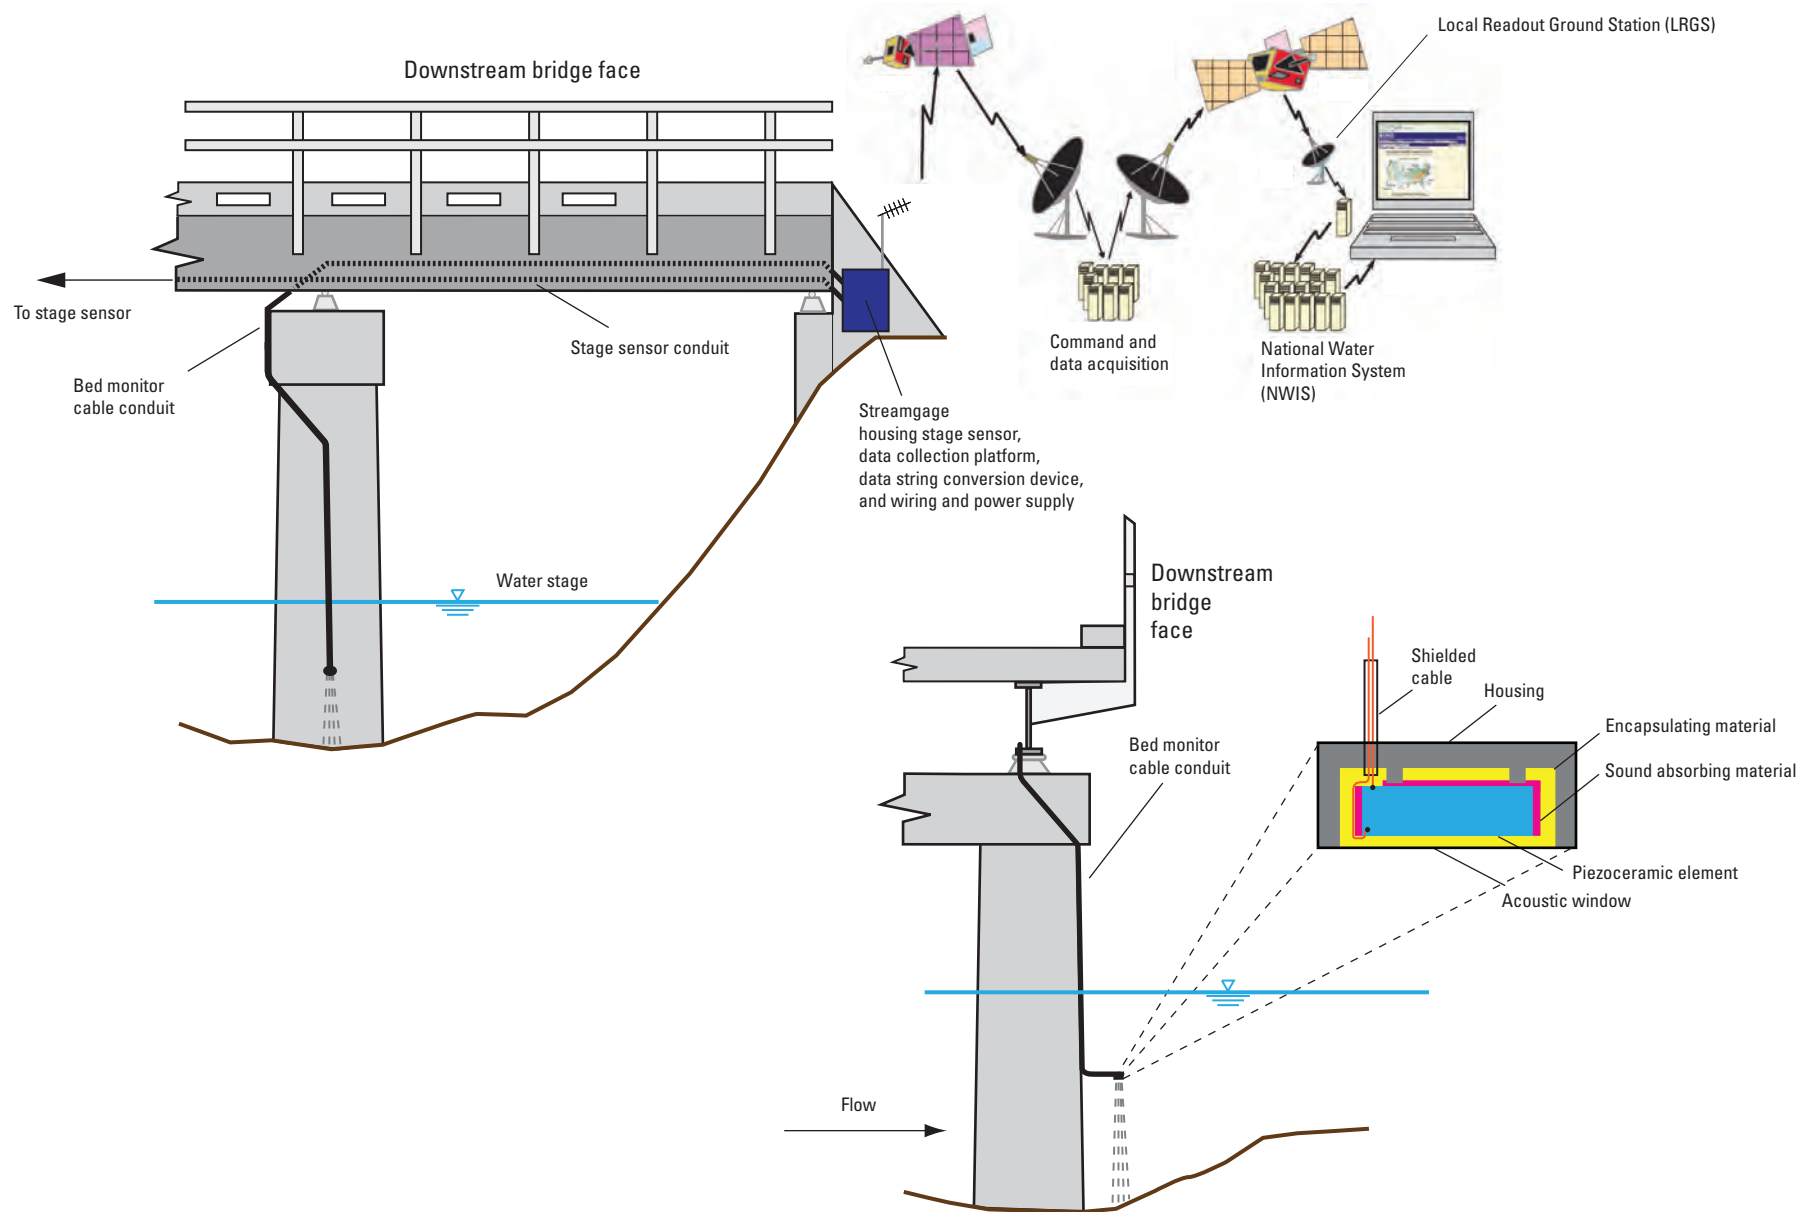
Figure 2. Internal configuration, installation, and data dissemination of a river channel-bed monitor.

The integration of an RCBM with a DCP used to record and transmit river stage at streamgages has allowed the monitoring of bed dynamics as a function of river stage (fig. 2). On an hourly basis, the DCP transmits stage sensor and bed monitoring inputs collected every 15 minutes through a series of satellites to a USGS office where the data are automatically uploaded into the USGS National Water Information System (NWIS) database (<http://waterdata.usgs.gov/nwis>). Data are updated to the Web from NWIS, resulting in a total time from field transmission to Web in approximately 7 to 8 minutes (U.S. Geological Survey, 2009, fig. 2).

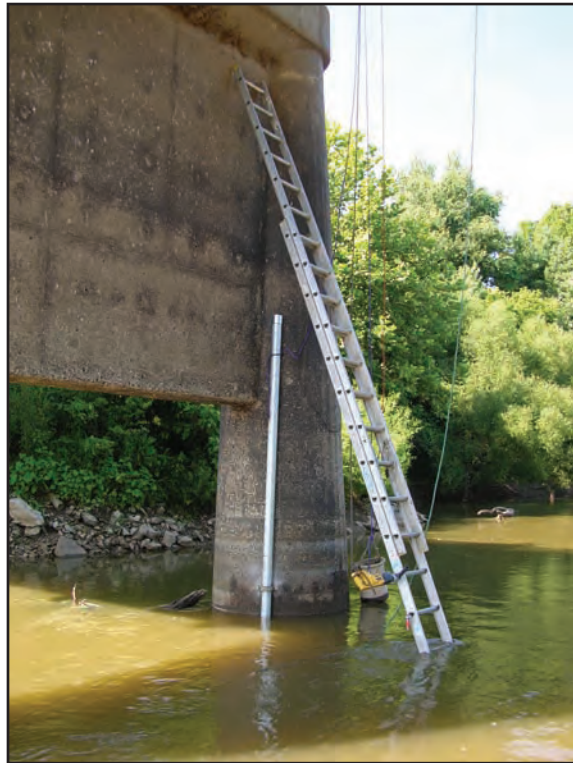
Installation of 3-inch galvanized steel pipe encasing the transducer head and shielded cable on the downstream side of the upstream conical column of pier 4.

Figure 4. Installation of a river channel-bed monitor on structure L-344 over the Chariton River near Prairie Hill, Missouri.

as conduit to protect the transducer head and shielded cable at the lower portion of the pier (fig. 4).

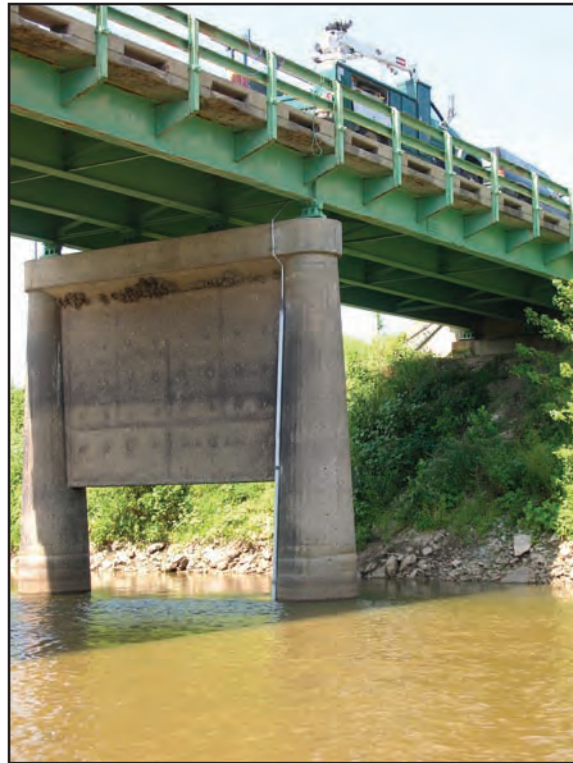
Installation of 1-inch to 3-inch galvanized steel pipe encasing the transducer head and shielded cable on the downstream side of the upstream conical column of pier 4 and between girders.

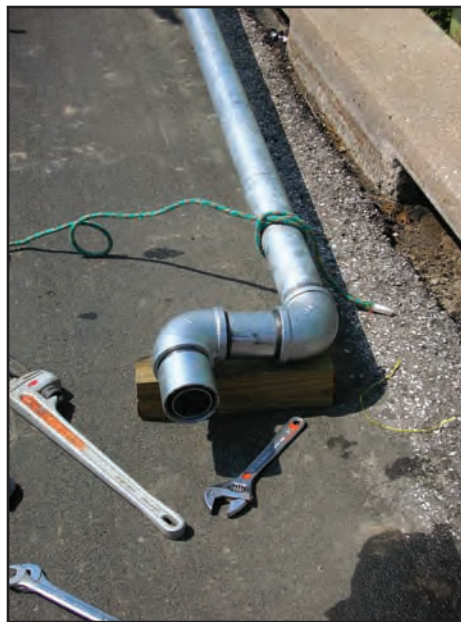
Three-inch galvanized steel pipe with offset encasing the transducer head, which is flush with pipe. Offset designed to prevent acoustic signal interference from pier and footing.

Schedule 40 steel pipe was used to protect the transducer head and cable from debris, in addition to providing stability and rigidity in the overall installation. Once the installation was complete, the power, data, and ground wires were connected to the NEMA 0183 to SDI-12 conversion device, which was subsequently wired to the DCP and programmed as an additional SDI-12 parameter to be received and transmitted. The initial depth measurement acquired by the data collector was checked in the field for accuracy. At this location, there was no offset that was needed. The initial and three subsequent depth measurements were verified using a measuring rod during the next hour (four 15-minute readings).

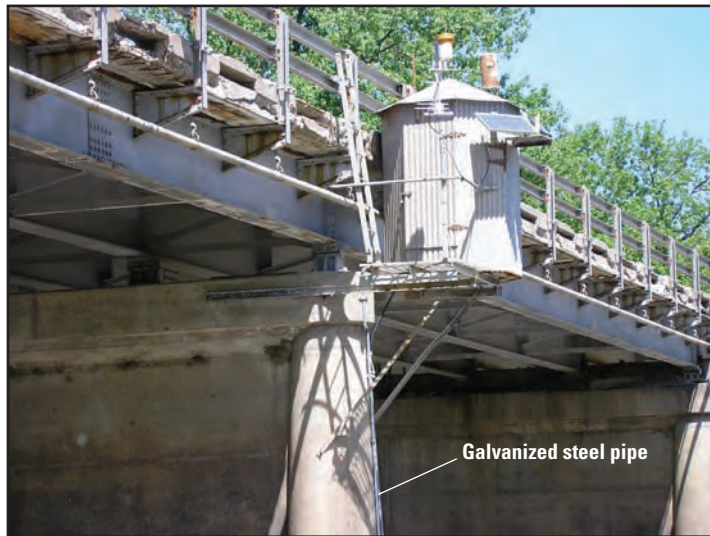
Existing streamgage shelter on the downstream side of pier 7. Note the galvanized steel pipe fastened on the conical column encasing the river channel-bed monitor shielded cable.

Figure 6. Installation of river channel-bed monitors on structure L-534 over the Chariton River at Novinger, Missouri.

Infrastructure associated with the USGS streamgage shelter was mounted on the cap at the downstream side of pier 7, which provided accessibility for the installation of the steel pipe that houses the RCBM at the upstream and downstream side of pier 7. A section of 1-inch pipe was installed on the downstream side of the downstream conical column paralleling the existing pressure sensor conduit (fig. 6) and another section of 1-inch pipe was installed on top of the cap and on the downstream side of the upstream conical column (fig. 6). Similar to the installation on structure L-344 near Prairie Hill, a reducer allowed the transition from the 1-inch pipe to the 3-inch pipe, which ultimately housed the transducer heads below the water surface at the downstream side of the upstream and downstream columns (fig. 6). Transmitted data from this location were processed in ADAPS and disseminated through the Web.

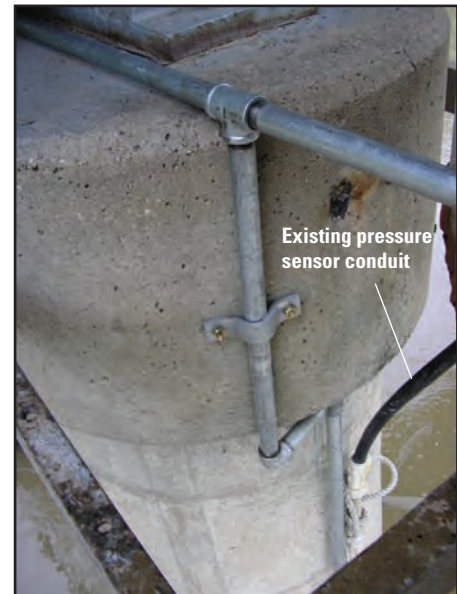
Installation of pipe junction to accommodate the downstream and the upstream river channel-bed monitor cables. Note the galvanized steel pipe that is parallel to the existing conduit for the pressure transducer on the downstream column.

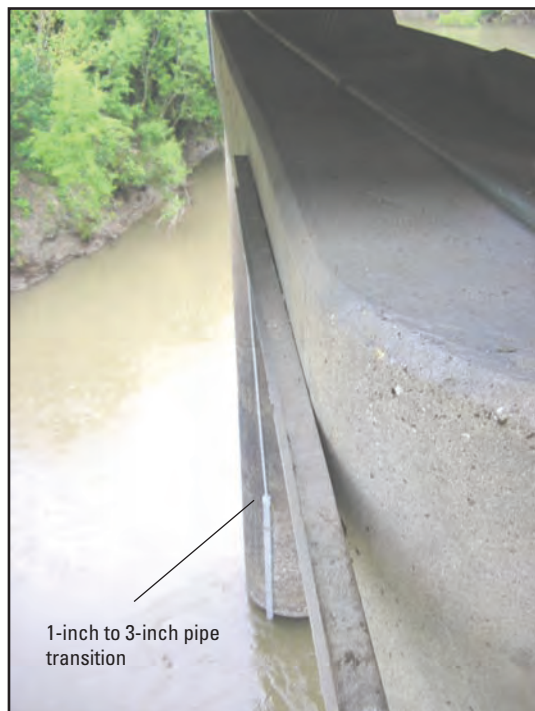
Installation of galvanized steel pipe along the top of the cap and continuing along the downstream side of the upstream conical column. Note the 1-inch to 3-inch pipe transition to accommodate the transducer head below the water surface.

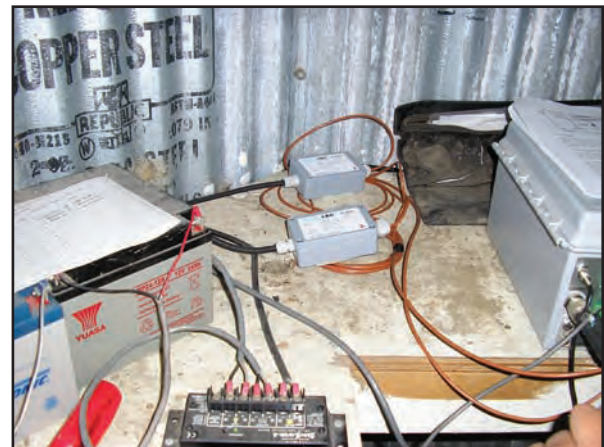
Wiring of NEMA 0183 to SDI-12 conversion devices necessary to ensure recording and transmission of river channel-bed monitor depth soundings.

To ensure data communication, a conversion device was used to convert the depth value, expressed as the National Marine Electronics Association (NMEA 0183) data string, from the RCBM's to the Serial Data Interface at 1200 Baud (SDI-12) required by the DCP. The DCP sends an address query at programmed intervals of 15 minutes to the conversion device. Once submitted, the conversion device “wakes up” from a lower-power “sleep” mode to collect NEMA 0183 depth value data from the RCBM. The data are then stored in a temporary buffer, converted to SDI-12, then sent to the DCP. The conversion device allows the user to enter an offset value when installing the RCBM and evaluating the current water depth. The DCP receives the depth value data string as SDI-12 from the conversion device and transmits it along with other resident streamgage parameters every hour by satellite telemetry to the USGS NWIS database.

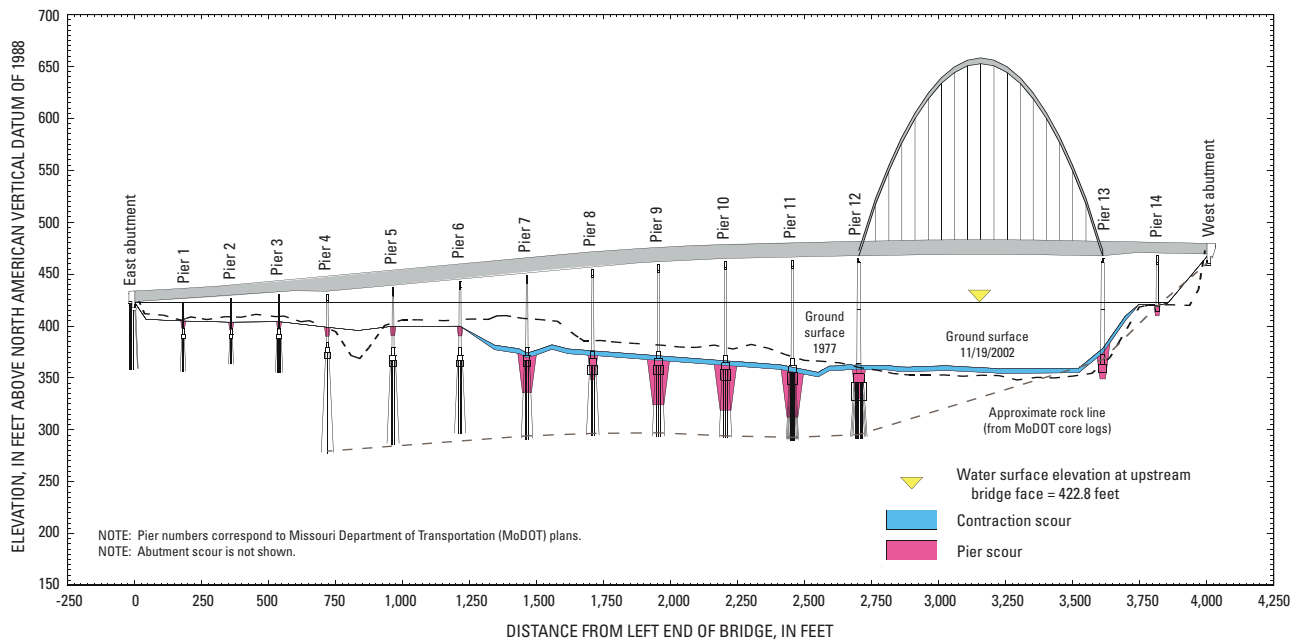
Figure 7. Predicted contraction and pier scour depths based on the 1993 flood for piers 1 through 14 and river channel-bed monitor design at pier 12 at structures A-1850 and A-4936 over the Mississippi River at Mehlville.

Substructure details from MoDOT bridge plans (Missouri Department of Transportation, 1977) provided the basis for an RCBM design at pier 12 (fig. 7). The complication in this design was ensuring that the acoustic signal had adequate clearance from the footer and seal course, yet minimizing the angle of the RCBM so that the signal would be returned and not reflected off the channel bottom in a direction away from the RCBM. Another concern was ensuring adequate protection to the RCBM (particularly at the upstream nose) on a large river (approximately 2,000 feet wide; Huizinga and Rydlund, 2004) with substantial hydrodynamic force and potential floating debris.

Based on the upstream and downstream protruding length of the footer and seal course from pier 12, an angle of 22 degrees was determined to provide adequate clearance to the channel bottom (fig. 7). Independent tests were conducted in the field with an RCBM positioned at a variety of vertical departures. The results of these tests showed that this angle (22 degrees) was sufficient to ensure signal return from the channel bottom without reflection from the transducer head. Proper protection of the RCBM and shielded cable was afforded by a 3-inch pipe used to encase the RCBM. The 3-inch pipe transitioned to a 1-inch pipe protected by 3- by 3-inch steel angle. The 3- by 3-inch angle provided protection to the location of a beveled edge (fig. 7), identified as a location of observed high water of record in MoDOT bridge plans (Missouri Department of Transportation, 1977). Above the beveled edge on the upstream and downstream nose of pier 12, polyvinylchloride (PVC) conduit was used to house the

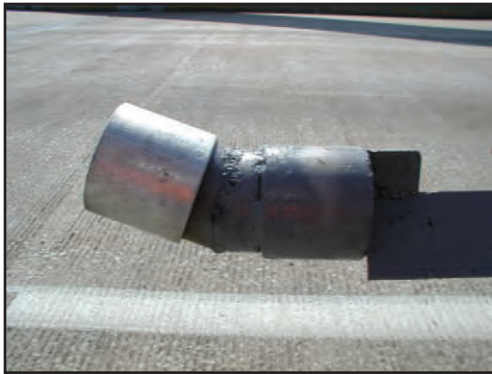
Three-inch galvanized steel pipe angled to clear footer and seal course, with enclosed transducer head flush with pipe. Note 3-inch angle welded to casing.

Figure 8. Installation of river channel-bed monitors on structures A-1850 and A-4936 over the Mississippi River at Mehlville, Missouri.

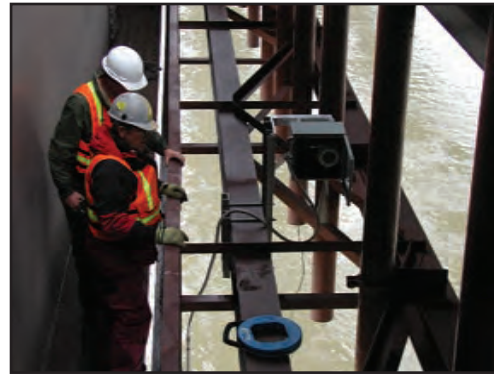
Installation of non-contact water surface sensor clamped to girders underneath bridge.

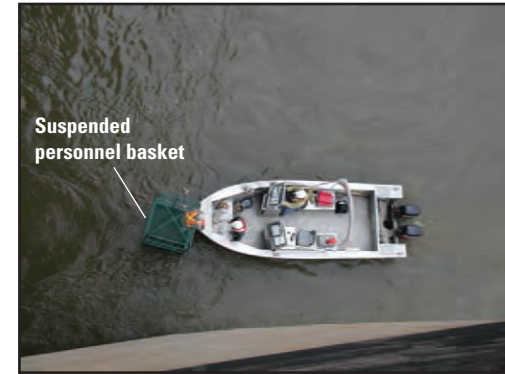
Safety boat used during installation of river channel-bed monitors. Note basket used to install pipe along the upstream and downstream pier nose.

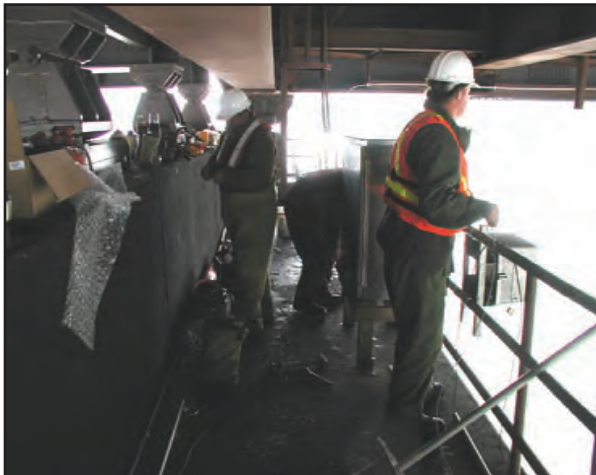
Wiring of river channel-bed monitors and non-contact water surface sensor to a shelter housing the NEMA 0183 to SDI-12 data conversion devices and data collection platform.

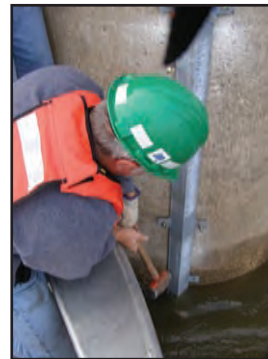
Installation of shielded cable in 1-inch steel pipe under 3-inch steel angle with expandable anchor bolts.

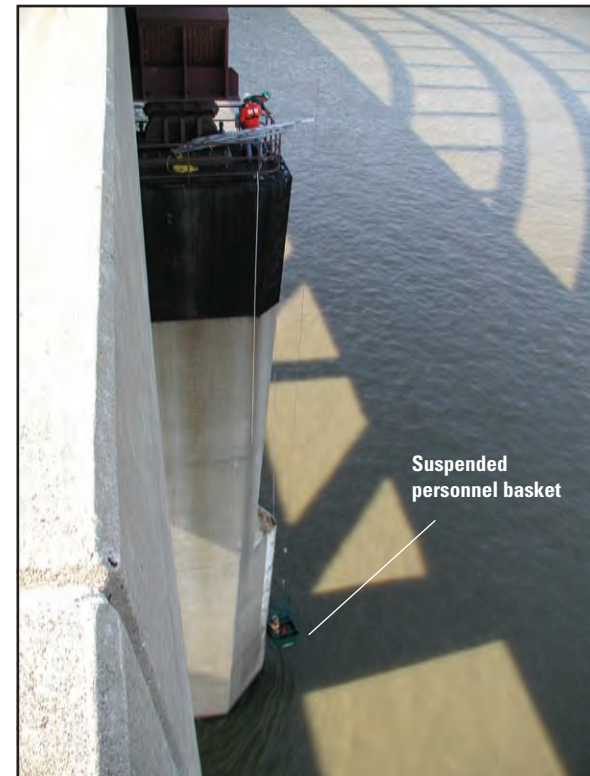
Installation of shielded cable in 1-inch steel pipe under 3-inch steel angle along the upstream nose of pier bent 12 using a suspended basket.

shielded cable along the remainder of the pier nose, along the pier cap, and into the shelter.

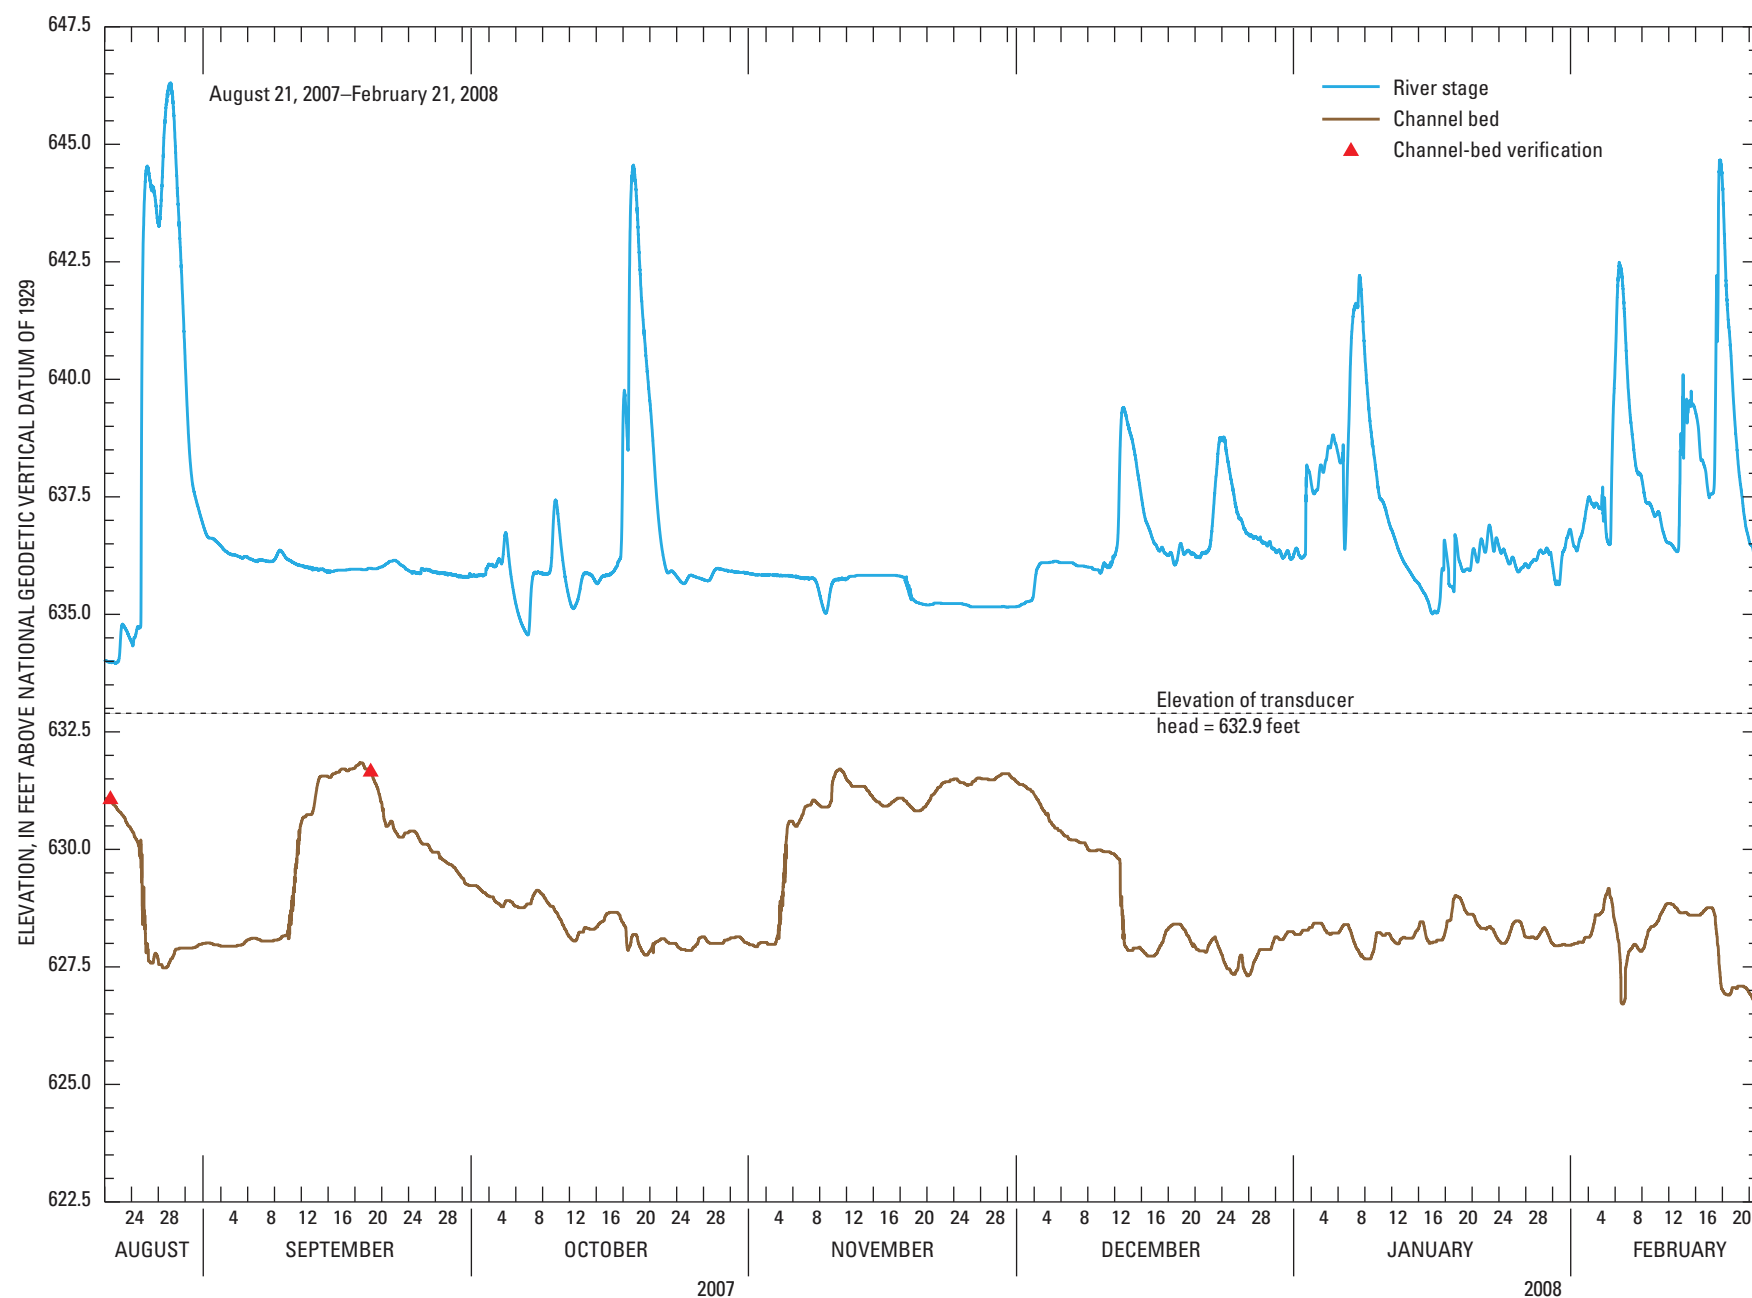
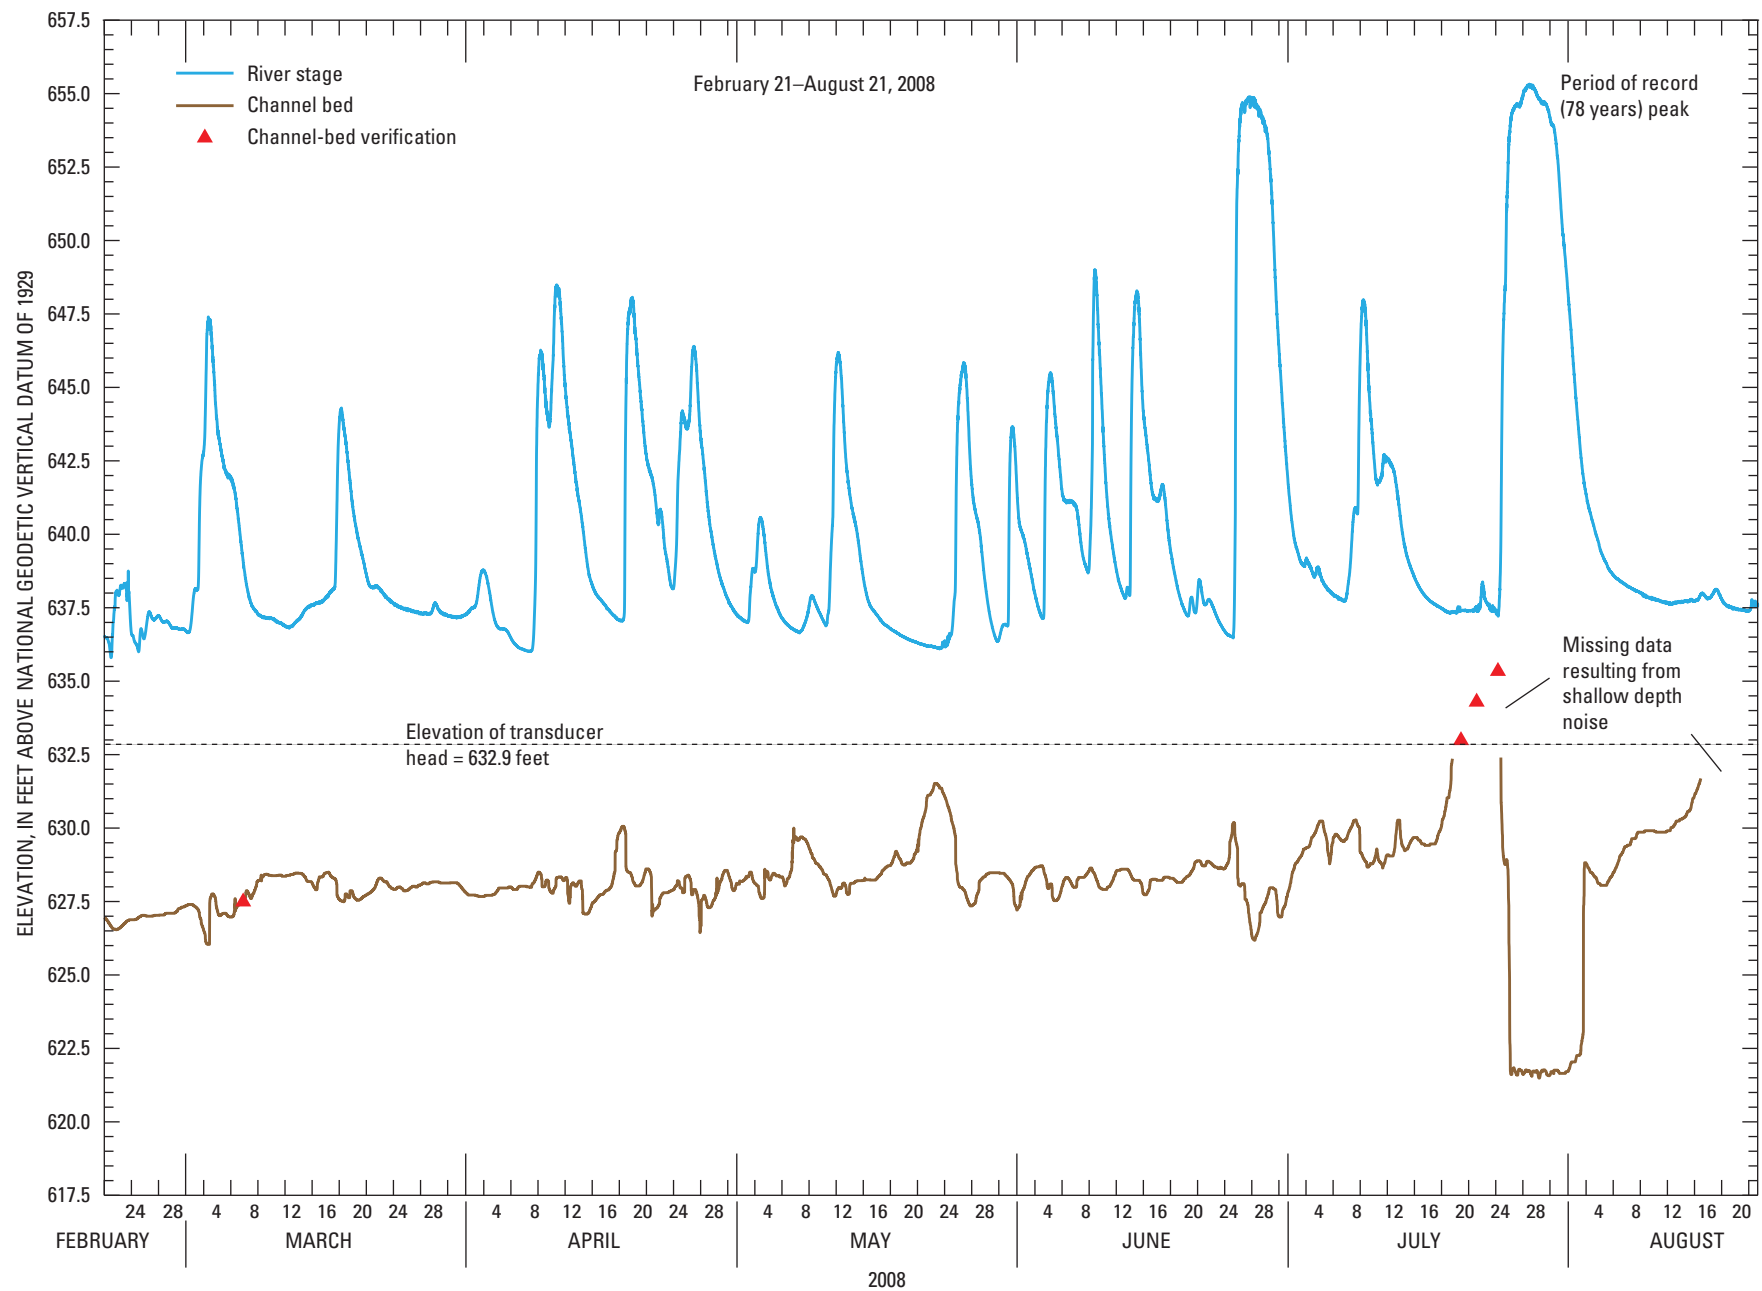
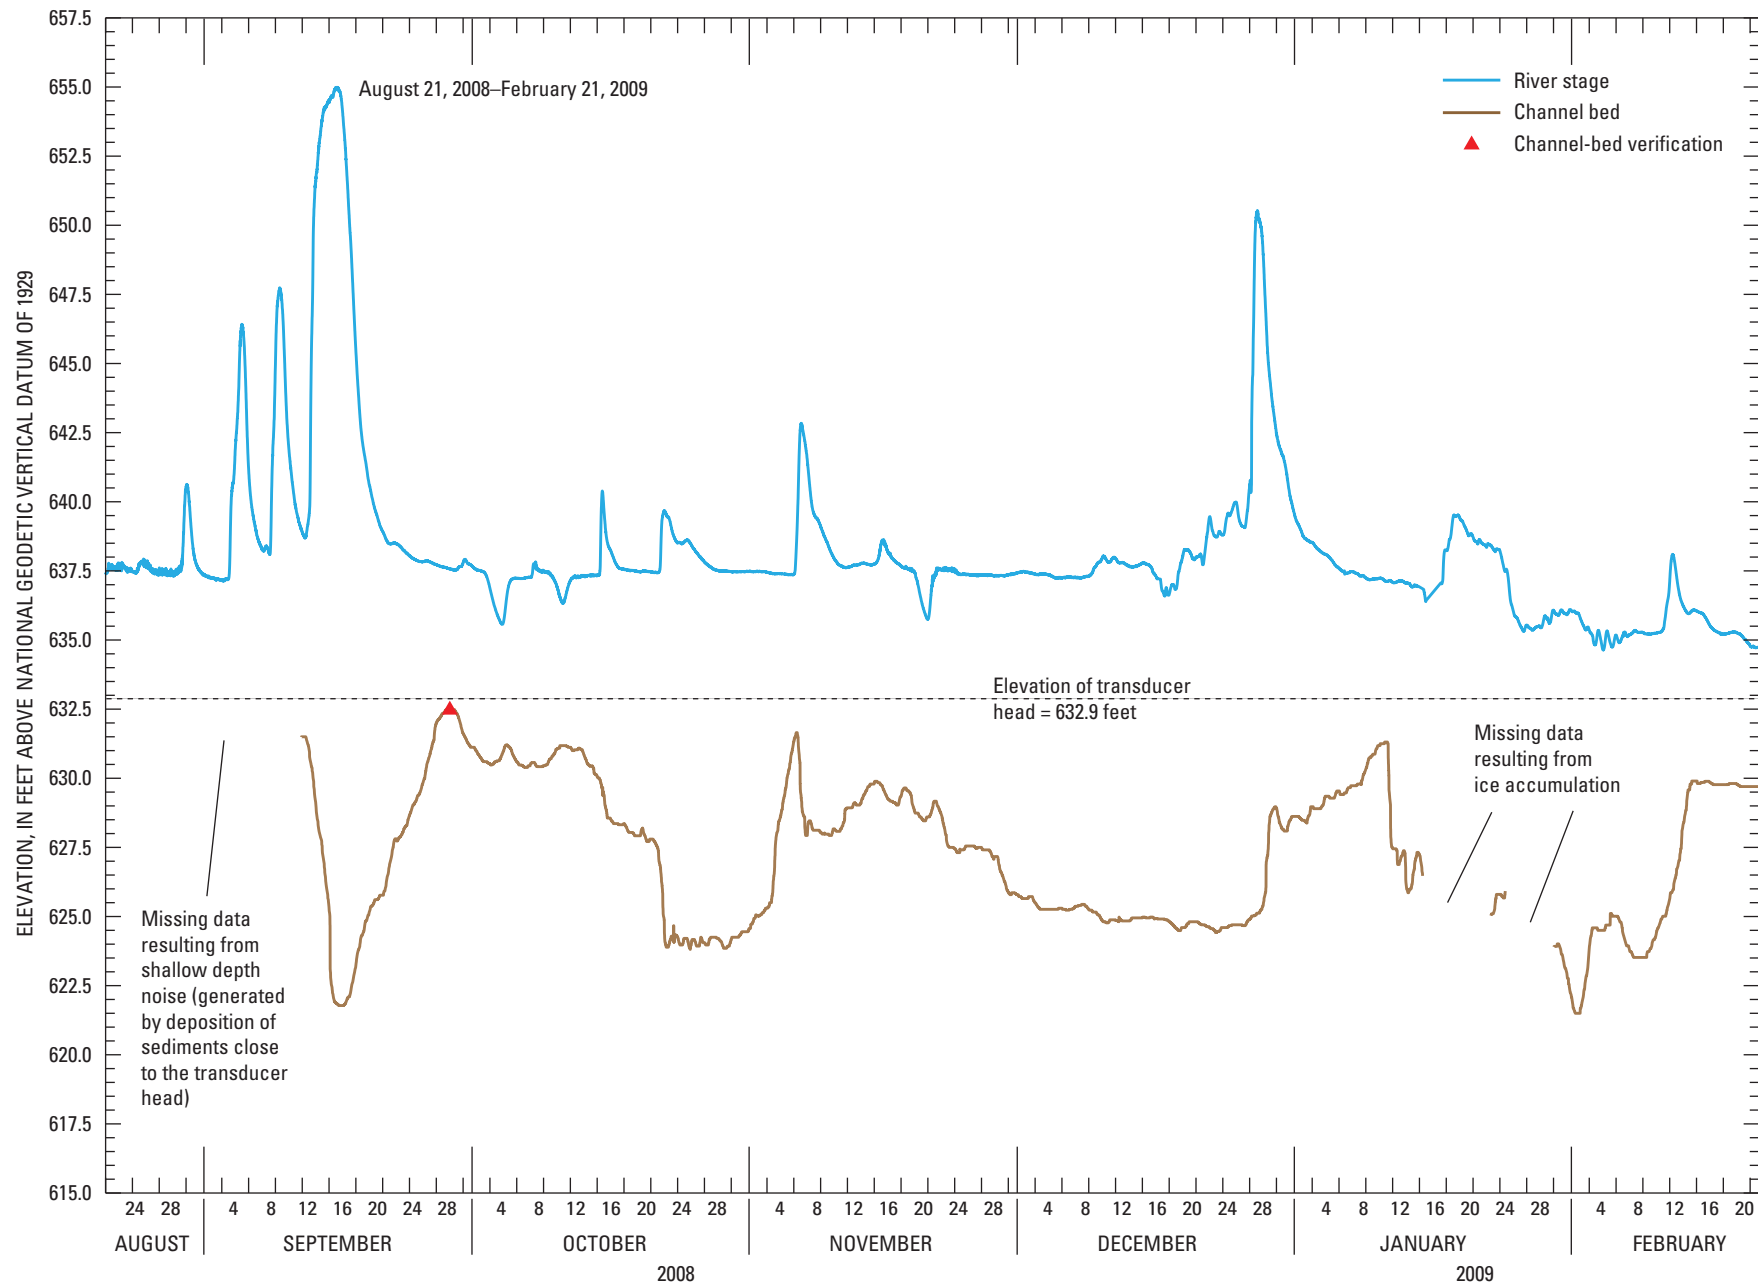
Figure 9. River channel-bed elevation at the downstream side of the upstream column of pier 4 and river stage from August 21, 2007, through August 21, 2009, for the Chariton River near Prairie Hill, Missouri (structure L-344).

On August 20, 2007, an RCBM was installed behind the upstream conical column of pier 4 as a pilot study. Within a few days, a 12-foot rise in stage triggered approximately 3 to 4 feet of scour (fig. 9). The scoured bed condition was sustained for nearly 17 days (fig. 9) until the presence of a bedform began to fill the hole during the middle of September 2007. Although the majority of the channel-bed record reflected some sort of direct hydrologic response at this location, the presence of bedforms as well as the flow impediment on which the RCBM was installed (pier 4) had contradictory or additive effects on expected scour and depositional behavior. A potential migrating bedform appeared before substantial scouring that occurred July 24, 2008, as a result of increasing velocities associated with the rising limb of the peak. The presence of this bedform may have produced an additive effect whereby scour was increased at the peak as the dune trough crossed the scour hole. Conversely, a filling effect can arise from cases where the crest of the bedform is passing through the scour hole (Pittaluga and others, 2004). For example, the rising limb of a prior peak on June 24, 2008, possessed nearly the same magnitude and duration as compared to the July 24, 2008,

Channel-bed data collection at this location was compromised from August 15 to September 12, 2008, as a result of deposition of sediments close to the transducer head of the RCBM (fig. 9). The occurrence of this deposition produced an indistinguishable channel-bed signature as a result of noise and secondary echoes. In addition, no valid data were collected during middle and late January 2009 because of ice accumulation (fig. 9). Another period of missing channel-bed and stage record occurred March 14 through March 16, 2009, as a result of equipment power failure.
